Proposed Posture Improvement Using REBA Method to Minimize The Occurance of Worker Muscle Complaints in Repairation at Tunas Toyota Cilegon

Naniek Utami Handayani¹ and Salsabila Rizka Azzahra²

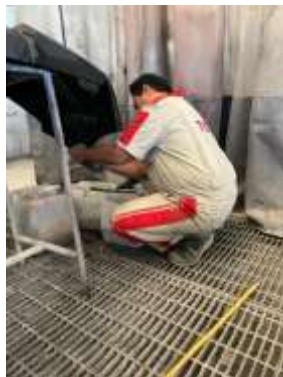
Fig. 1. Worker 1

Rapid Entire Body Assessment is a method developed in the field of ergonomics and can be used quickly to assess the work posture or posture of the neck, back, arms, wrists, and legs of an operator as influenced by coupling factors, external loads supported by the body and work activities [3]. The following is one example of an assessment of the REBA method.

Based on observations of work postures in car repair activities using the ErgoFellow software. The following are the steps in assessing posture using ErgoFellow 3.0:

Worker 1 performs car repairs in a position that is not ergonomic. The position makes the neck of the worker

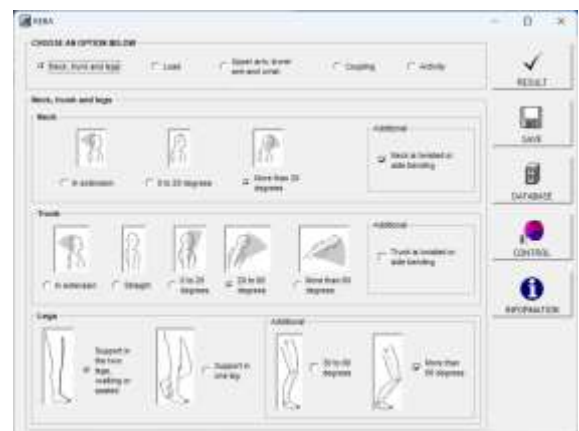
Fig. 2 Neck, Trunk, and Legs Assessment

- Neck, Trunk, and Legs Assessment

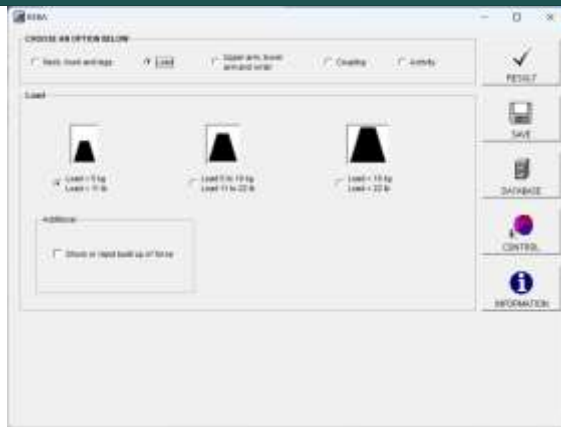
Fig. 3 Load Assessment

- Load Assessment

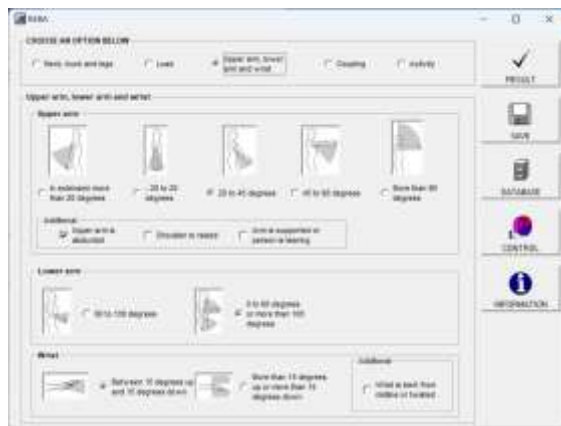
Fig. 4 Upper arm, Lower arm, and Wrist Assessment

- Upper arm, Lower arm, and Wrist Assessment

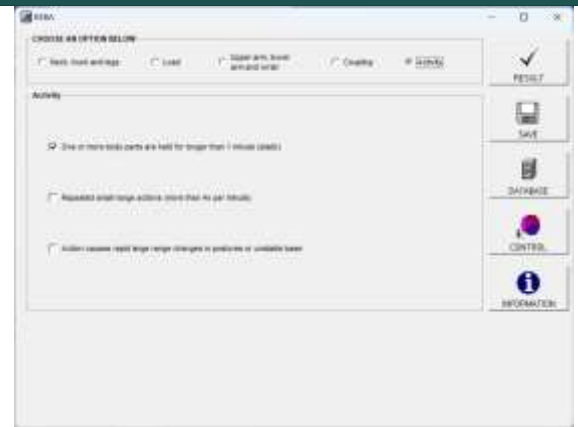
Fig. 6 Activity Assessment

- Activity Assessment

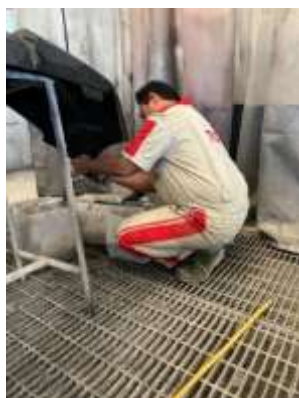
Fig. 8 Worker 1

form an angle of more than 20 degrees down, and the neck of the worker also rotates not parallel to the midpoint of the body. Then the torso of the technician also forms an angle between 20 and 60 degrees. Technician 1 uses both legs as a fulcrum, but both legs bend so that they make an angle of more than 60 degrees. This worker one posture in the REBA method has a value of 9, with an indication of high risk that requires immediate action.

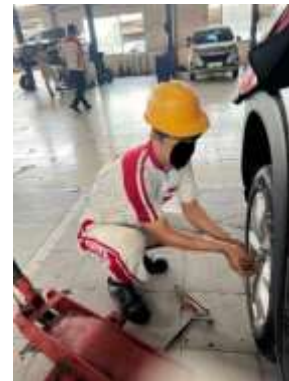
Fig. 9 Worker 2

Worker 2 performs car repairs in a position that is not ergonomic. The position makes the neck of the worker form an angle between 0 to 20 degrees down (almost parallel to the torso), and the neck of the worker does not rotate and is parallel to the midpoint of the body. Then the technician's torso also forms an angle between 20 to 60 degrees. Technician 2 uses both legs as a fulcrum, but both legs bend so as to make an angle of more than 60 degrees. This worker two posture in the REBA method has a value of 5 with an indication of moderate risk that requires action.

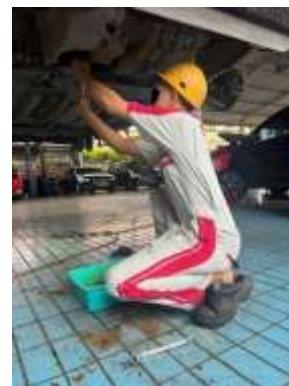
Fig. 10 Worker 3

Worker 3 is performing car repairs in a position that is not ergonomic. This position makes the neck of the worker form an angle between 0 to 20 degrees down (almost

parallel to the torso), and the neck of the worker does not rotate and is parallel to the midpoint of the body. Then the technician's torso also forms an angle between 0 to 20 degrees. Technician 3 uses one of his legs as a fulcrum, but both legs bend so that it makes an angle of more than 60 degrees. In the posture of worker 3, the position of the hands exceeds 90 degrees which makes workers experience complaints. This posture of worker 3 in the REBA method has a value of 11 with an indication of very high risk which requires action at this time.

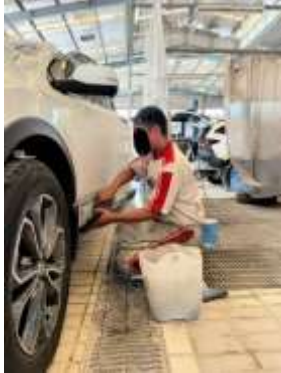
Fig. 11 Worker 4

Worker 4 is performing car repairs in a position that is not ergonomic. This position makes the neck of the worker form an angle between 0 to 20 degrees down (almost parallel to the torso), and the neck of the worker does not rotate and is parallel to the midpoint of the body. Then the technician's torso also forms an angle between 0 to 20 degrees. Technician 4 uses one of his legs as a fulcrum, but both legs bend so as to make an angle between 20 to 45 degrees. In the posture of worker 4, the position of the hands exceeds 60 degrees which makes workers experience complaints. This posture of worker 4 in the REBA method has a value of 8 with an indication of high risk that requires immediate action.

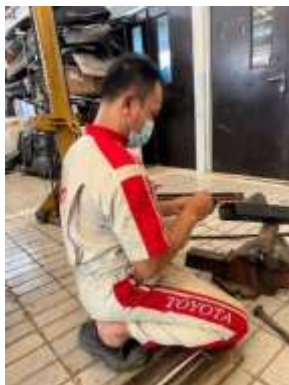
Fig. 12 Worker 5

Worker 5 performs car repairs in a position that is not ergonomic. The position makes the neck of the worker form an angle exceeding 20 degrees down, and the neck of the worker does not rotate and is parallel to the midpoint of the body. Then the technician's torso is also straight. Technician 5 uses both legs as a fulcrum, but both legs bend so that it makes an angle of more than 60 degrees. The posture of worker 5 in the REBA method has a value of 4, with an indication of moderate risk that requires action.

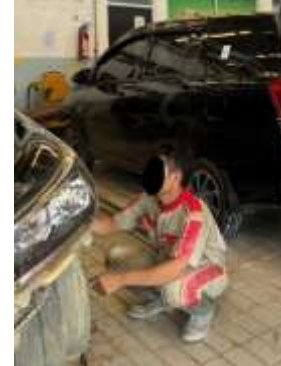
Fig. 13 Worker 6

Worker 6 performs car repairs in a position that is not ergonomic. This position makes the neck of the worker form an angle between 0 to 20 degrees down (almost parallel to the torso), and the neck of the worker does not rotate and is parallel to the midpoint of the body. Then the technician's torso also forms an angle between 20 to 60 degrees. Technician 6 uses both legs as a fulcrum, but both legs bend so as to make the angle more than 60 degrees. The posture of worker 6 in the REBA method has a value of 6 with an indication of moderate risk that requires action.

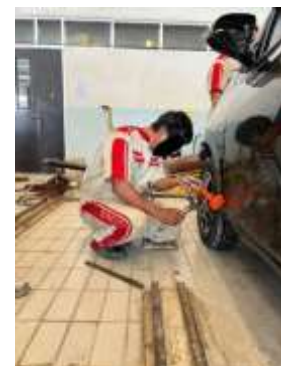
Fig. 14 Worker 7

Worker 7 performs car repairs in a position that is not ergonomic. The position makes the neck of the worker form an angle exceeding 20 degrees and the neck of the worker does not rotate and align with the midpoint of the

body. Then the torso of the technician also forms an angle between 20 and 60 degrees. Technician 7 uses one of his legs as a support, but both legs bend so that it makes an angle of more than 60 degrees. In the posture of worker 7, the position of the hands forms an angle between 20 to 45 degrees which makes workers experience complaints. This posture of worker 7 in the REBA method has a value of 11 with an indication of very high risk which requires action at this time.

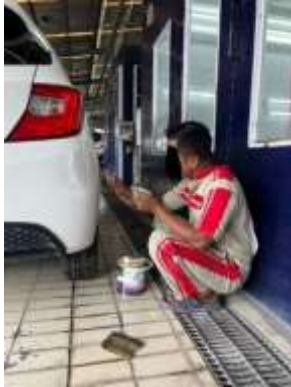
Fig. 15 Worker 8

Worker 8 performs car repairs in a position that is not ergonomic. The position makes the neck of the worker form an angle between 0 to 20 degrees down (almost parallel to the torso), and the neck of the worker does not rotate and is parallel to the midpoint of the body. Then the torso of the technician also forms an angle between 0 to 20 degrees. Technician 8 uses both legs as a fulcrum, but both legs bend so as to make an angle of more than 60 degrees. This posture of worker 8 in the REBA method has a value of 6, with an indication of moderate risk that requires action.

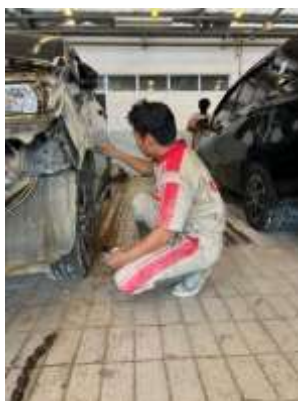
Fig. 16 Worker 9

Worker 9 performs car repairs in a position that is not ergonomic. The position makes the neck of the worker form an angle between 0 to 20 degrees down, and the neck

of the worker also rotates not parallel to the midpoint of the body. Then the technician's torso also forms an angle between 0 to 20 degrees. Technician 9 uses one of his legs as a fulcrum, both legs bend so that it makes an angle of more than 60 degrees. This posture of worker 9 in the REBA method has a value of 9 with an indication of high risk that requires immediate action.

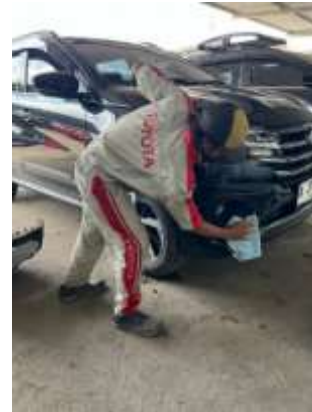
Fig. 17 Worker 10

Worker 10 performs car repairs in a position that is not ergonomic. The position makes the neck of the worker form an angle exceeding 20 degrees, and the neck of the worker rotates and is not parallel to the midpoint of the body. Then the torso of the technician also forms an angle between 0 and 20 degrees. Technician 10 uses one of his legs as a fulcrum, but both legs bend, making the angle more than 60 degrees. In the posture of worker 10, the position of the hands makes an angle between 45 to 90 degrees which makes workers experience complaints. This posture of worker 10 in the REBA method has a value of 11 with an indication of very high risk which requires action at this time.

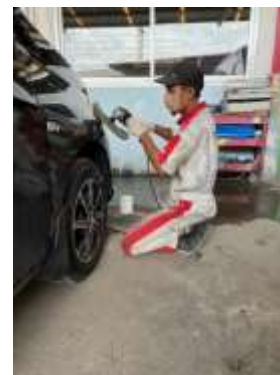
Fig. 18 Worker 11

Worker 11 performs car repairs in a position that is not ergonomic. The position makes the neck of the worker form an angle between 0 to 20 degrees down (almost

parallel to the torso), and the neck of the worker does not rotate and is parallel to the midpoint of the body. Then the technician's torso is straight. Technician 11 uses both legs as a fulcrum, but both legs bend so that they make an angle of more than 60 degrees. This posture of worker 11 in the REBA method has a value of 4 with an indication of moderate risk that requires action.

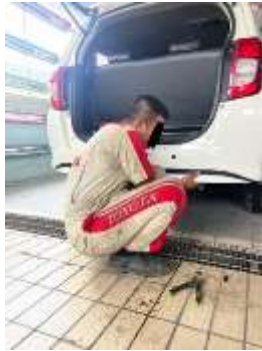
Fig. 19 Worker 12

Worker 12 performs car repairs in a position that is not ergonomic. The position makes the neck of the worker form an angle exceeding 20 degrees and the neck of the worker does not rotate and align with the midpoint of the body. Then the torso of the technician also forms an angle between 20 and 60 degrees. Technician 12 uses one of his legs as a support, but both legs bend so that it makes an angle of more than 60 degrees. In the posture of worker 12, the position of the hands forms an angle between -20 to 20 degrees which makes workers experience complaints. This posture of worker 12 in the REBA method has a value of 8, with an indication of high risk that requires immediate action.

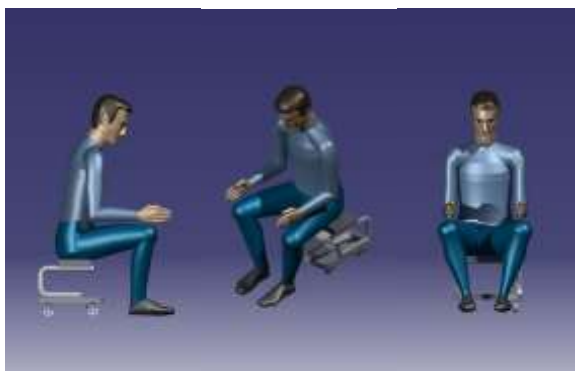
Fig. 22 Posture Improvement

After improving posture using the Creeper, a posture assessment using REBA was carried out again. The following are the results of the REBA assessment after improvement.
