# Sabkha Soil Improvement Utilizing Stone Columns: A Case Study

**Abstract**-This paper discusses the ground improvement using stone columns for the construction of a new lattice communication tower in a gas plant in Saudi Arabia's Eastern Province. The geotechnical investigation data collected at the project site revealed subsurface conditions of loose to very loose sabkha soil with low SPT and N values ( $< 4$ ) between 2.7 m and 13 m depth. Depending on the design requirements, ground improvements must be considered under the foundation of lattice towers to operate reliably and safely. The study discusses geotechnical investigations, stone column construction methods, and verification or confirmation tests used to ensure the project's successful execution. The outcomes of this study indicate that stone columns can be utilized efficiently to enhance bearing capacity and reduce settlement beneath foundations constructed on sabkha soils.

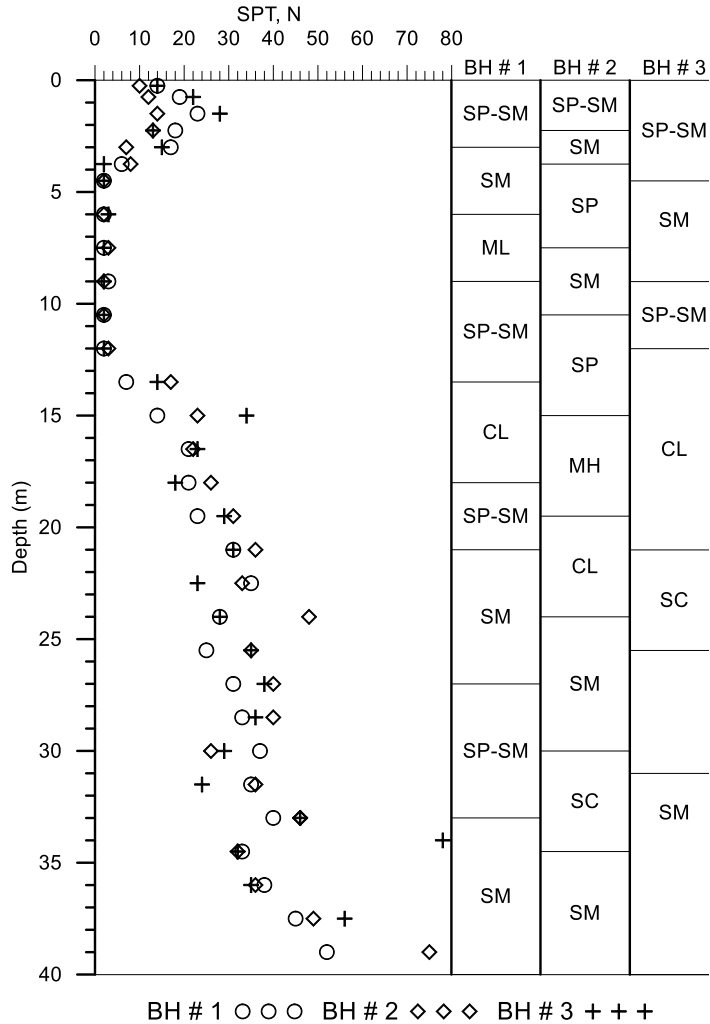
Figure 2: SPT, N values, PCPT test, and the subsurface strata encountered in boreholes.

Subsurface stratigraphy and design parameters are evaluated up to the maximum drilling depth using field exploration and laboratory testing of representative soil samples. Figure 2 shows a summary of SPT, N values, PCPT test, and the subsurface strata encountered in boreholes. The stratigraphy observed from borings generally indicates the presence of a top 3 m loose to medium dense sand with a silt layer, followed by very soft, compressible strata (Sabkha) up to 13 m depth. The density of the strata beneath the sabkha layer ranges from medium to very dense layers, and this condition continues to the maximum depth of investigation. The ground water level was checked in all the boreholes 48 hours after finishing the drilling of each borehole. In this investigation natural ground water table was 2.7 m from ground surface encountered in all boreholes. It was discovered that the drilling profiles were varied in each borehole. This is one of the sabkha characteristics, which are changes in physical and chemical properties that occur vertically and horizontally over a short distance [1], [14].

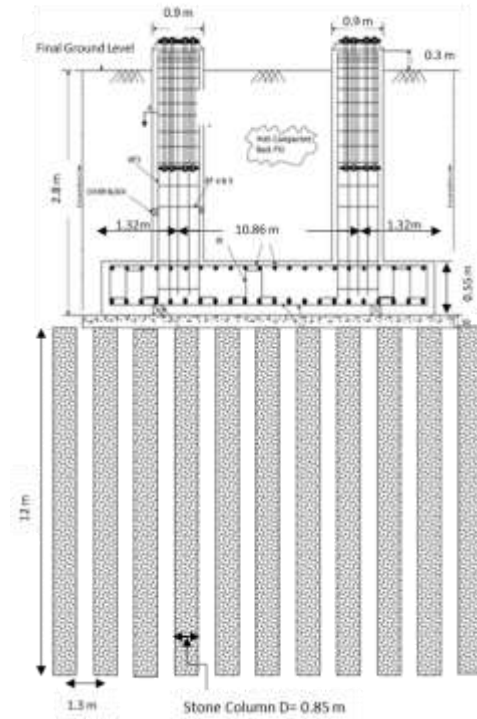
Figure 3a: Dimensions of the Tower Foundation

The stone columns are suggested to be installed on a square grid at a spacing of 1.3 m c/c. Based on the design calculation, the proposed stone column diameter is 0.85 m and the treatment depth is up to 12 m below bottom of mat foundation.

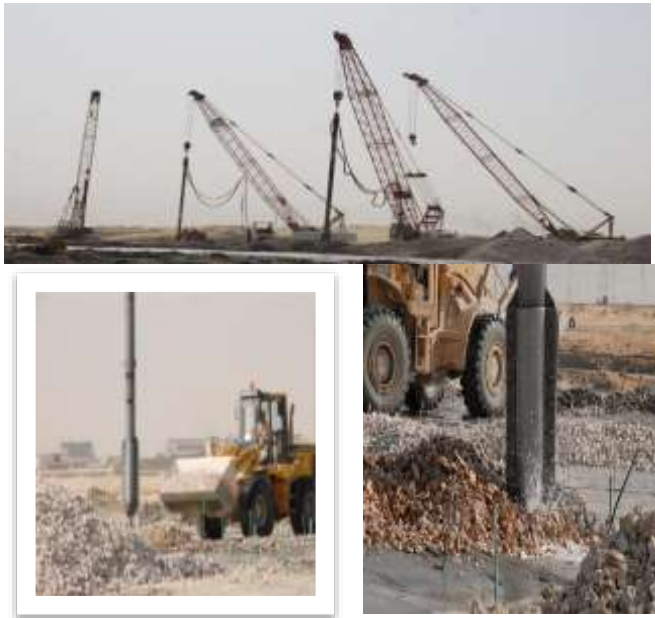
Figure 6: Installation of stone columns on-site

For the equipment used by contractors, pressure is used to monitor the compaction of stone columns. The gauge pressure is related to the resistance offered by the stone column aggregate material being compacted. The pressure increases as the material gets compacted, and for a gauge pressure of 200 bars, the desired maximum compaction of the ground is achieved. Stone columns compacted up to a maximum of 220 bars of pressure. The images in the Figure 6 are from actual construction sites.

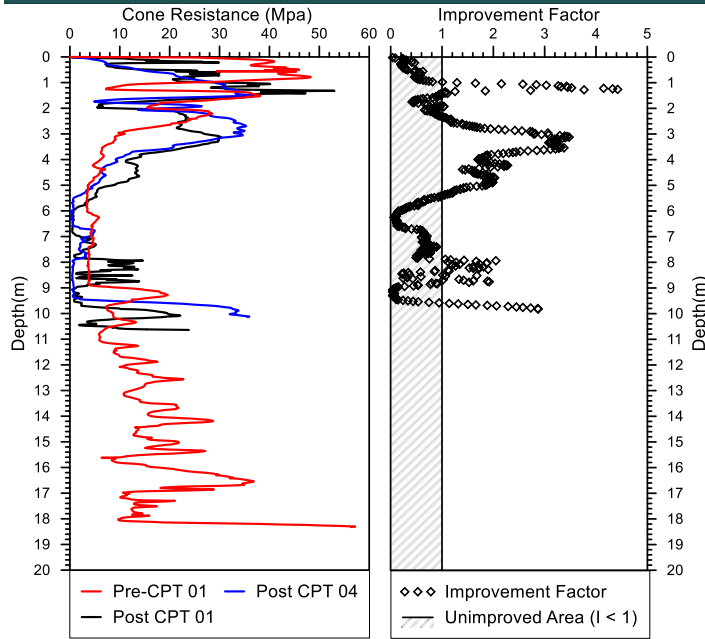
Figure 7: Pre-and post-PCPT in the soil improvement area.

is shown in Figure 7 and Figure 8. Another method for assessing the effect of the installation stone column is to compare the tip resistance between post-PCPT and pre-PCPT readings. The following is how the ratios are expressed:

The data shows slight improvement in the sandy layers above sabkha (0 to 3 meters) where sand or sand with silt is present. It was also observed that some of the pre-PCPT values are greater than the post-PCPT values, which validates A. Abas's (2015) hypothesis that this is due to the disruption of cemented soil bounding during the wet vibro-replacement activity and a lack of surface confinement [4]. Nevertheless, there was a noticeable improvement in the sabkha layer, particularly in the upper 1–3 meters of the stratum. The Sabkha's sandy, clayey composition, with shell fragments mixed in with sand from the top layers, could explain the improvement. This improvement could be explained by the sabkha soil in this location, which is classified as sandy soils with shell fragments and a fine content of less than 20%. The sabkha under 6 m below ground level contains fine soils more than 50 percent. Field observations have demonstrated that vibro compaction techniques are ineffective in improving the density of soils when the fine content exceeds 20% (24). This was confirmed by Hussin (1987) and Mackiewicz (2007), who found that vibro compaction techniques had no significant effect when the fine materials reached 12 percent [19], [20]. The soil under sabkha was classified generally as sand, and the value of pre-CPT increases with depth, reaching refusal at a depth of approximately 11 to 12 m. As shown in Figure 7 and Figure 8, the depth of refusal points in the post-CPT test decreased by more than 5 m. The reduction in refusal depth demonstrates that this layer has earned minor improvements because of the stone column installation process.

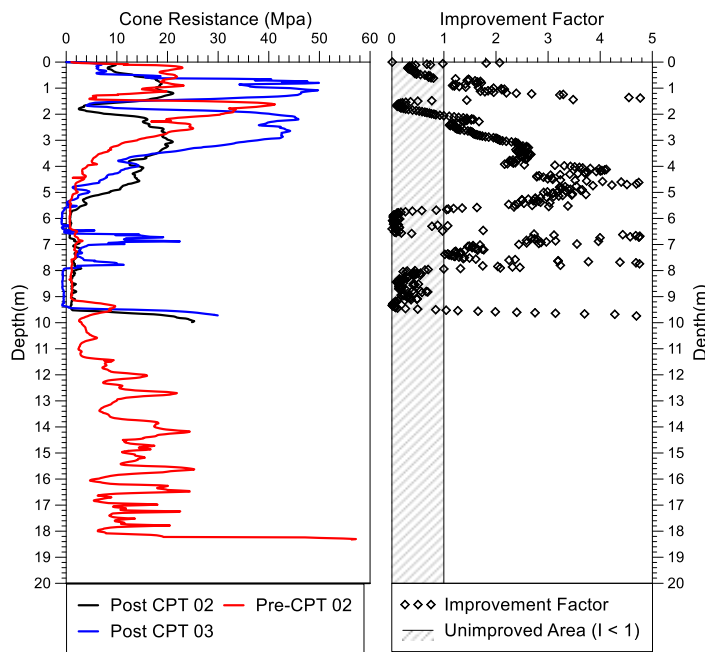
Figure 8: Pre-and post-CPT in the soil improvement area.

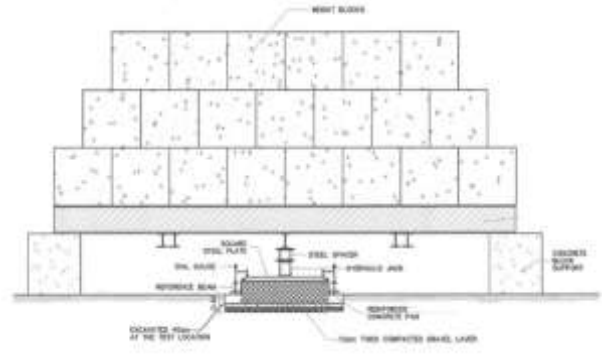
Figure 9: A plate load test setup.

Footing load tests were performed to confirm the requisite design capacity of the composite area, which included natural soils and the stone column. The concrete footing utilized is 2 m × 2 m in dimension and 0.6 m thick. The footing was loaded according to the loading schedule shown in Table . The maximum applied stress is 300 kPa, which is 1.5 times the required bearing capacity. The pressure was applied to the

concrete footing by a hydraulic jack reacting against a 120-ton kentledge platform of concrete blocks (see Figure 9). The relationship between applied load and settlement is depicted in Figure 10. The test was carried out in accordance with ASTM D1194. According to the test results, the maximum value of settlement is 2.44 mm, which is only 9.8 % of the maximum allowable settlement of 25 mm.

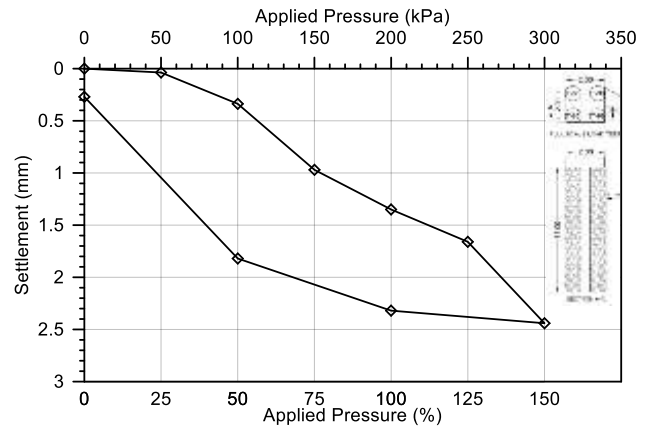
Figure 10: The results of the plate load test.

- The Full-Scale load test results have shown excellent improvement in the ground conditions. The maximum settlement of load test footing at 100% of the Design Pressure was recorded as 1.35 mm while settlement at 150% of Design Pressure was 2.44 mm only.
